# SAFETY BRIEF

Volume 9, No. 2

## Auger Elevator - Failure Modes and Effects Case Study\*

by Dennis B. Brickman\*\* and Ralph L. Barnett†

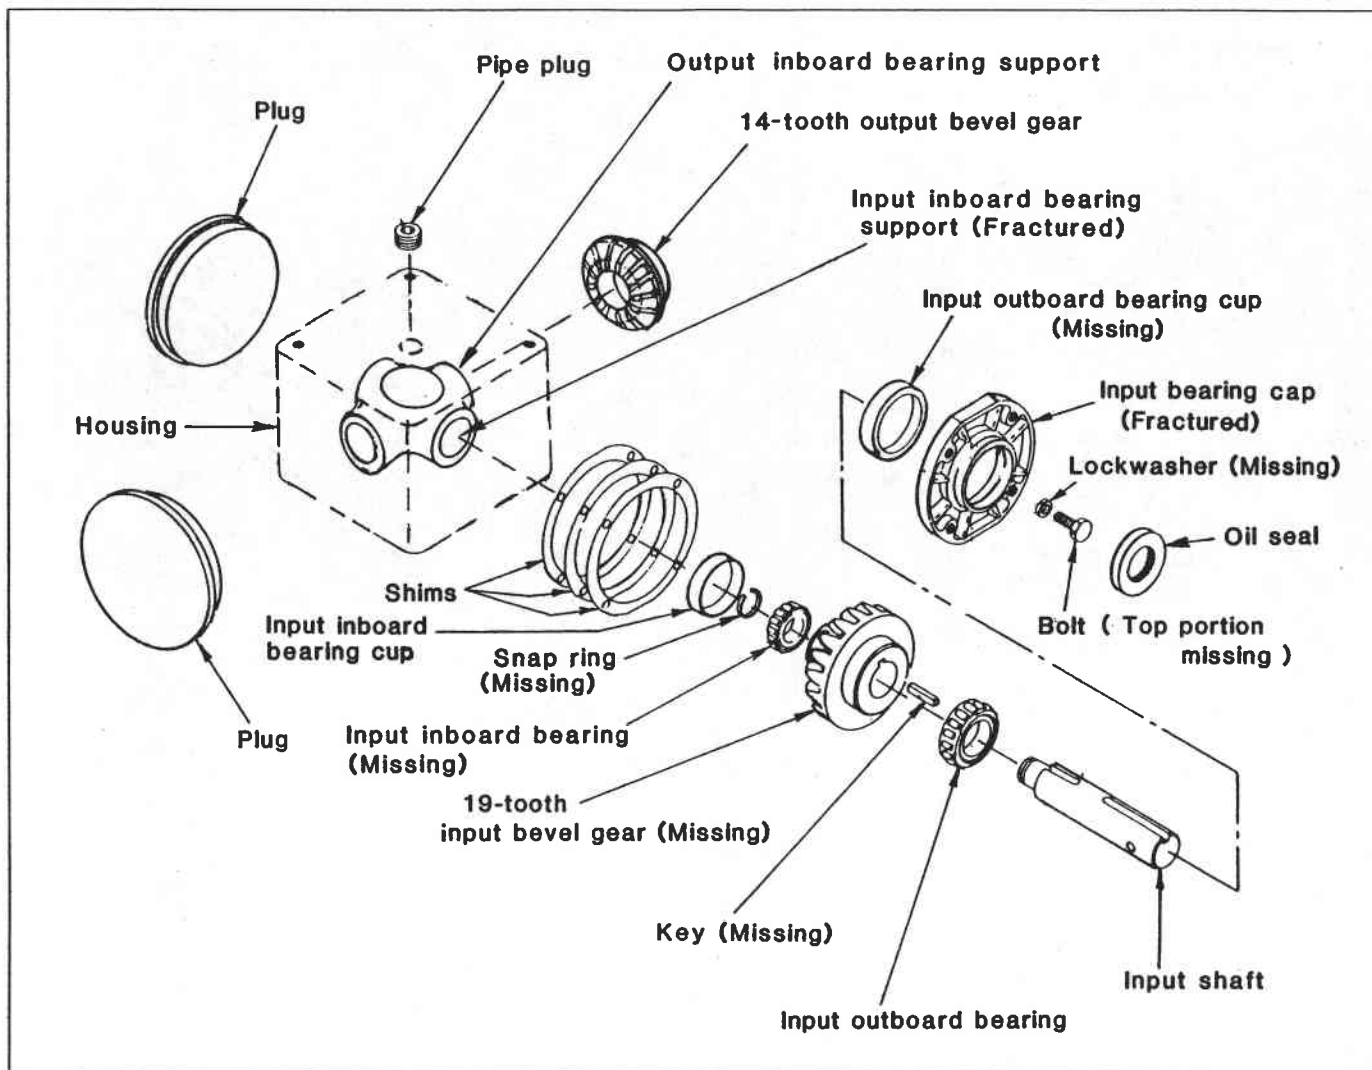
Fig. 2 is an exploded view of the gear box involved in the subject accident. Two of the six inboard bearing supports were being utilized in this application. After the accident, the input inboard bearing support was fractured as shown in Fig. 3; the output bevel gear and the output shaft appear on the right side of Fig. 3. The cast iron fracture surfaces were subjected to metallurgical examination and were found to be free of casting defects. The cast aluminum bearing cap on the input side appears in Fig. 4 where the individual fragments have been reassembled. It should be noted that one of the four retaining bolts is missing. An examination revealed that the bolt was broken off in the housing and was not present at the time of the gear box failure.

An extensive search of the accident site was conducted using seven metal detectors, but a group of input components was never recovered as indicated in Fig. 2. The entire output assembly, including the out-

put bevel gear, remained *in-situ* in pristine condition. The remaining parts in Fig. 2 were all intact and operational.

Figure 2. Gear box exploded view

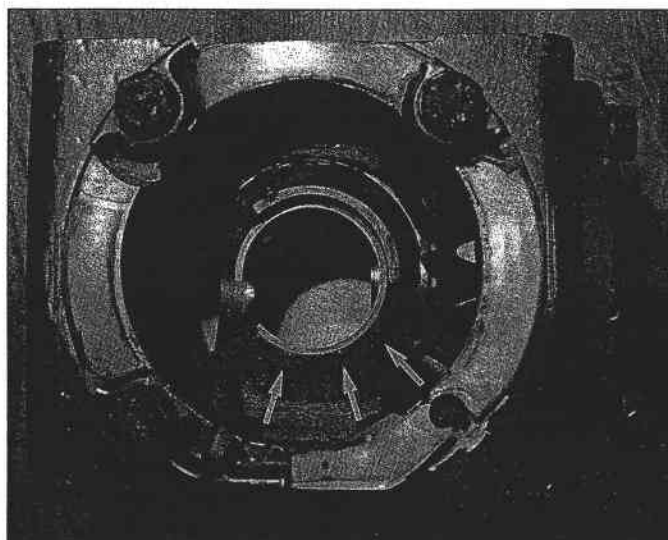
Figure 3. Accident gear box - fractured input inboard bearing support. Arrows indicate typical fracture surface.

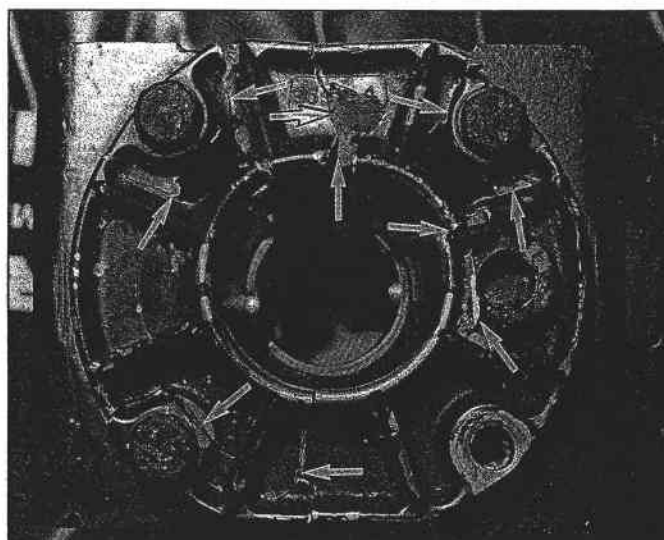
Figure 4. Accident gear box - fractured and reassembled input bearing cap. Arrows indicate bearing cap fractures.

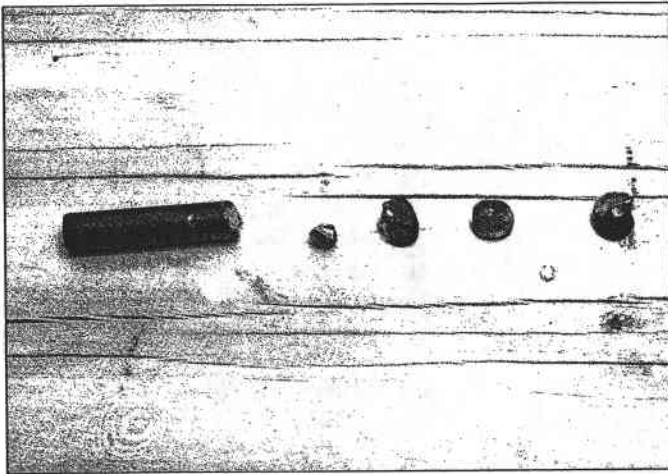
1. The tramp metal parts were all broken by the meshing gears. For example, Fig. 6 shows a hardened pin after being injected into the inrunning nip created by the bevel gears.
2. No distress of any kind was inflicted on the gear box components.
3. No telltale marks were observed on either the input or output bevel gears. Recall that the output bevel gear on the accident gear box showed no nicks or imperfections.

Figure 6. Hardened pin fractured by meshing gears

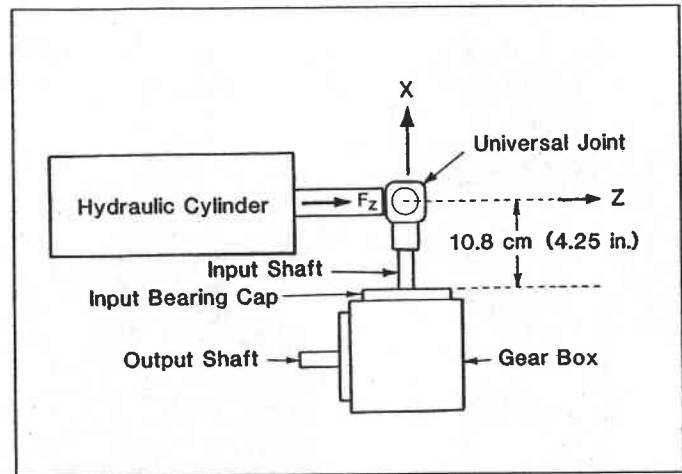
Figure 8. Test setup - shear loading

Using the test setup illustrated in Fig. 8, exemplar gear boxes were subjected to a shear force ( $F_x = 0$ ,  $F_y = 0$ ,  $F_z > 0$ ) in the +z direction parallel to the output shaft. An

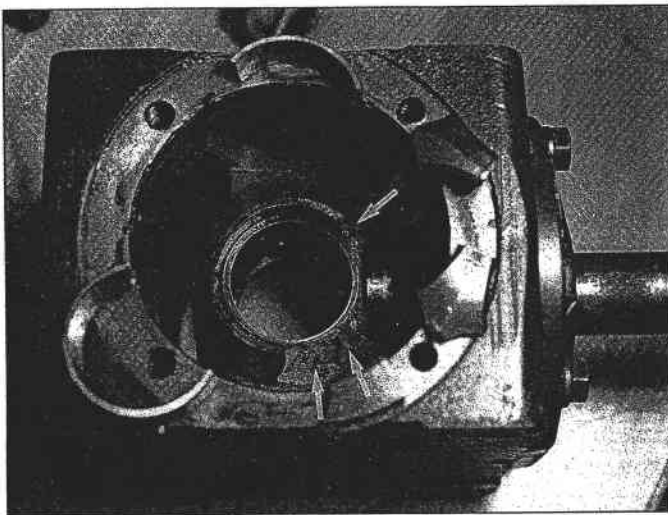
4. An exemplar gear box with a fractured input inboard bearing support, shown in Fig. 7, was mounted on an exemplar auger elevator and operated for 20 minutes. The hardness of the input inboard bearing support fragments ranged from 92.9  $R_B$  to 94.2  $R_B$ .

To study the effect of pure axial compression on the input shaft ( $F_x < 0$ ,  $F_y = F_z = 0$ ), an exemplar gear box was compression loaded in a universal testing machine to failure. The cast iron input inboard bearing support fractured under an ultimate compressive load of 66,367 N (14,920 lbf). The appearance of the input inboard bearing support fracture was similar to the accident gear box as shown in Fig. 7; however, in contrast to the accident gear box, no failure occurred in the cast aluminum input bearing cap. Indeed, no loading is transferred to the input bearing cap since the input shaft slides freely through the oil seal.

Figure 7. Exemplar gear box - fractured input inboard bearing support after compression loading. Arrows indicate typical fracture surface.

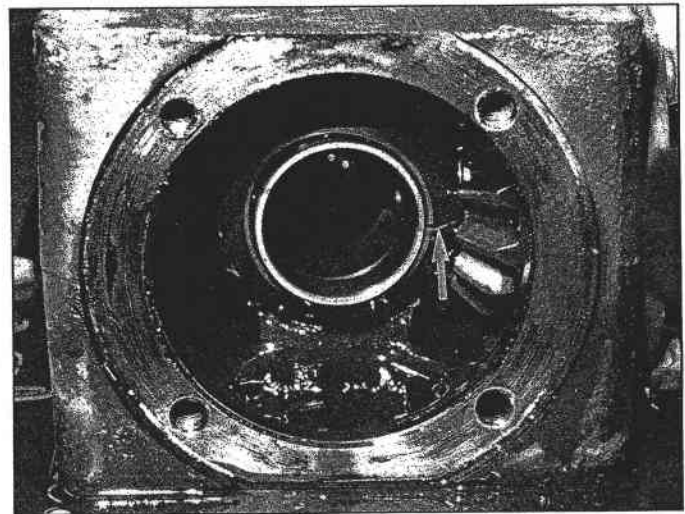
Figure 9. Exemplar gear box - arrow indicates fractured input inboard bearing support after shear loading

ultimate shear load of 22,704 N (5,104 lbf) was obtained with an exemplar gear box with 3 bolts in the input bearing cap. A second gear box achieved 25,324 N (5,693 lbf) with 4 bolts in the input bearing cap. In both cases, the input bearing cap fractured in a pattern similar to the accident input bearing cap and a single crack appeared in the input inboard bearing support near the output gear as shown in Fig. 9 and Fig. 10.

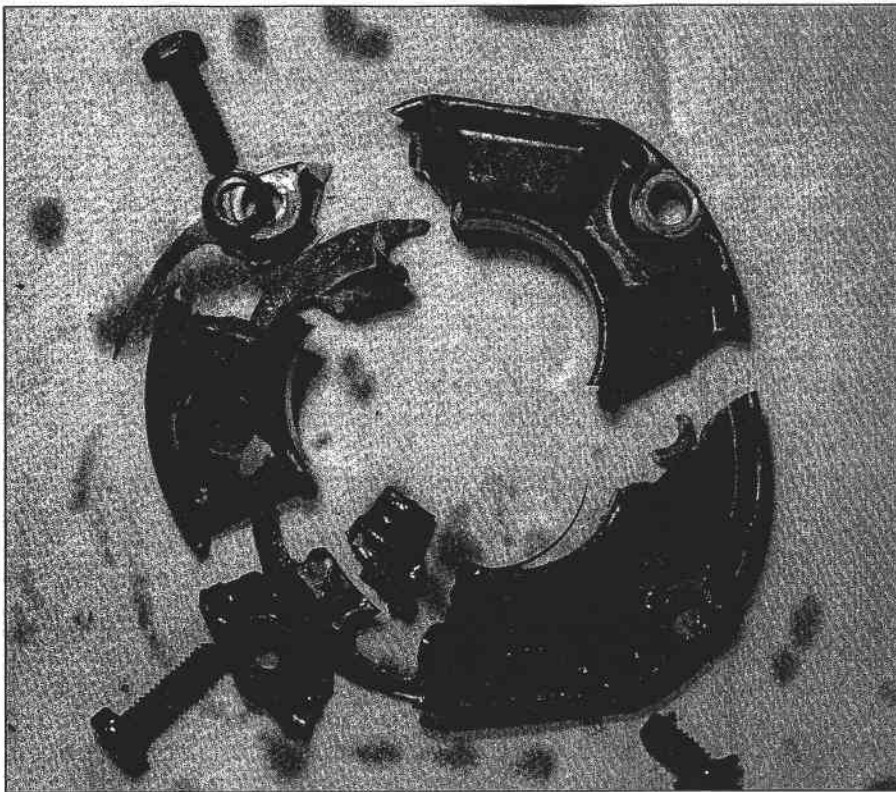
The complete failure mode observed in the accident gear box can be produced by a compression force transmitted through a collapsed or "bottomed out" PTO shaft which is not parallel in any direction to the gear box input shaft. The required fracture forces are too large to be applied statically by a tractor, and therefore, the fracture mode must be produced using impact. Such impact loads might arise if the posi-

Figure 10. Exemplar gear box - fractured input bearing cap after shear loading
