# SAFETY BRIEF

Volume 9, No. 2

## Auger Elevator - Failure Modes and Effects Case Study\*

by Dennis B. Brickman\*\* and Ralph L. Barnett†

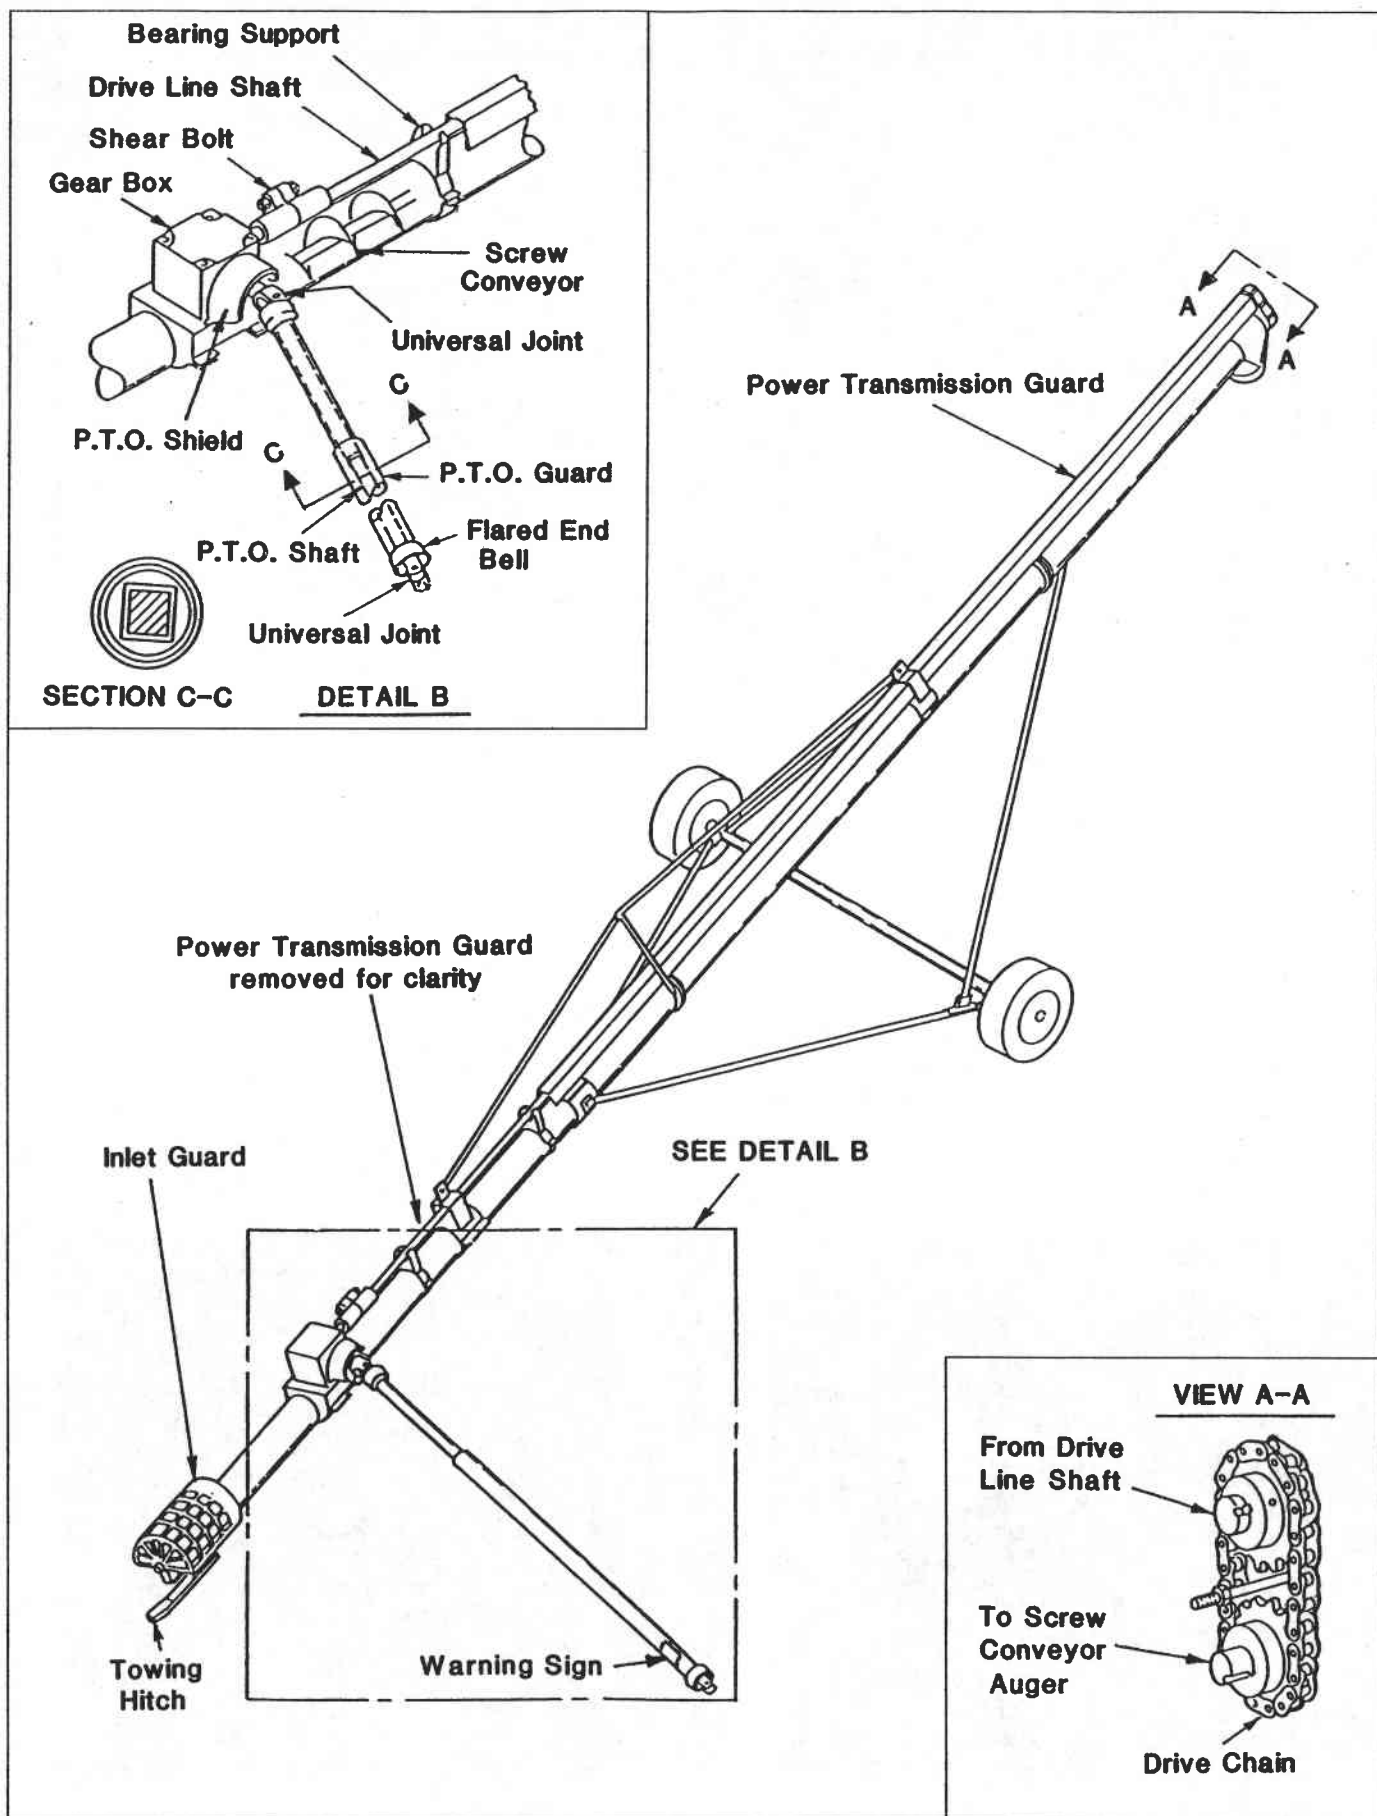
A tragic accident occurred when the gear box on an auger elevator failed, releasing the appliance end of a PTO shaft while the tractor end was driven at the standard speed of 540 rpm. At the time of the accident, the tractor was oriented with its longitudinal axis perpendicular to the longitudinal axis of the auger elevator. The tractor was being used as a stationary power plant and transmitted a torque to the input side of a right angle gear box by means of a telescoping PTO shaft with universal joints on both ends as depicted in Figure 1.

Figure 1. Auger Elevator

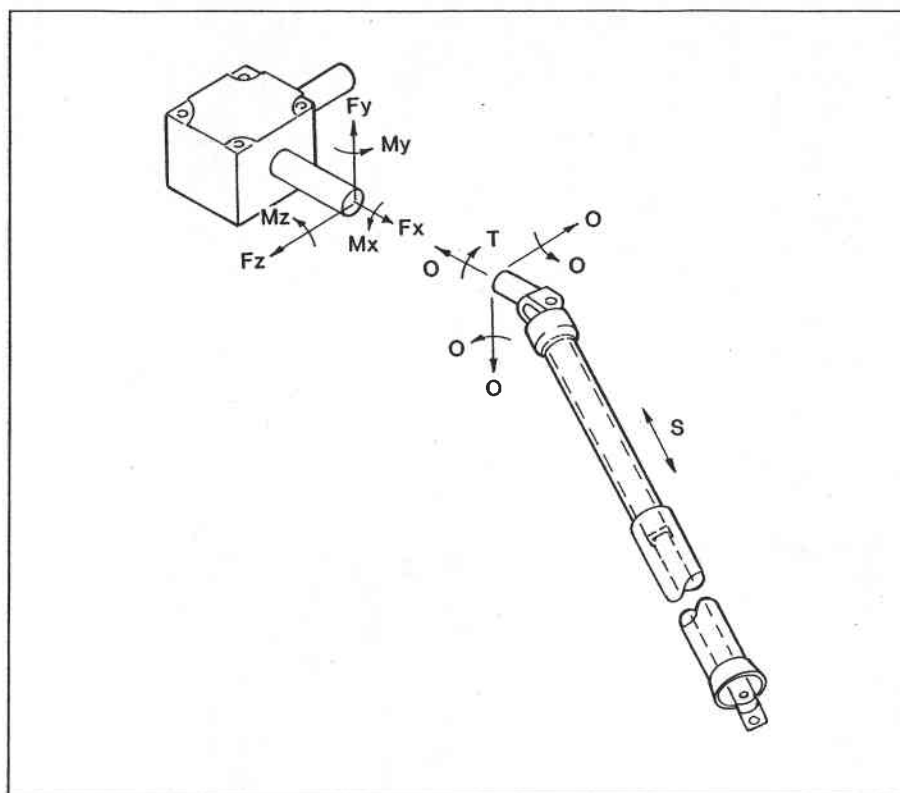
must lie along an axis through the hinge points, that is, through the member. The telescoping nature of the PTO shaft guarantees almost zero thrust, and consequently, the force delivered to the gear box input shaft will have zero components in the x, y, and z directions ( $F_x = 0$ ,  $F_y = 0$ ,  $F_z = 0$ ) as illustrated in Fig. 5. Universal joints can only transmit torsion. Consequently,  $M_y = 0$  and  $M_z = 0$ . Therefore, the only resultant load that can be transmitted to the gear box input shaft is the torsional load  $M_x = T$ , where T is the output torque of the tractor PTO neglecting inefficiencies.

Figure 5. Most general expected loading - input shaft
