Triodyne Inc. Consulting Engineers and Scientists

SAE 910128

Photographic Documentation and Analysis In Vehicle Accident Reconstruction

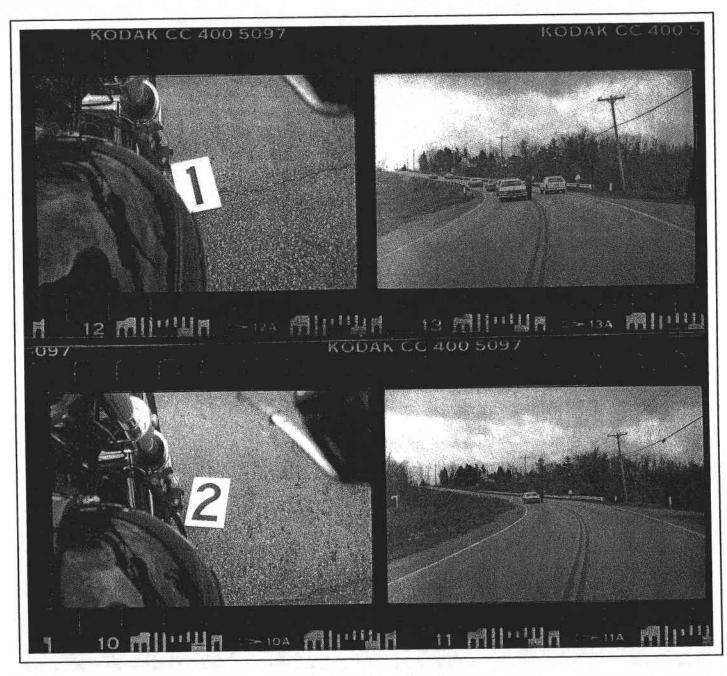
Figure 4 - Frames 13 and 11 on the film strip are views of the automobile as seen by the motorcyclist as both were positioned at distances corresponding to locations 1 and 2 seconds respectively prior to collision.

Sometimes it is important to be able to demonstrate the view of each driver prior to a collision. A simple two-camera technique can be used for this purpose. The method has been used for a motorcycle/automobile collision in Figures 4 and 5.

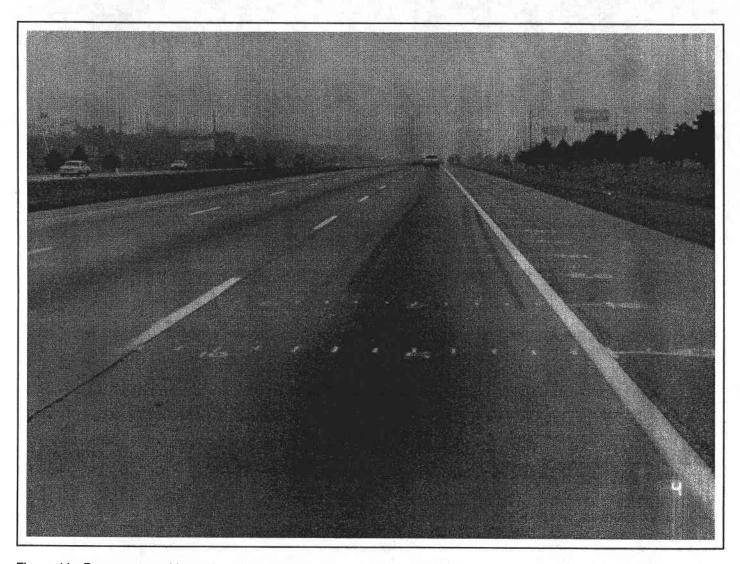
Figure 11 - Pavement markings placed on a busy interstate using spray chalk.

The accident site shown in Figures 11 and 12 was marked in the following way:

- A reference point (permanent station mark on the pavement surface) was selected;
- Marks were made at 10-foot intervals and numbered along the roadway throughout the accident site;
- At points of interest, marks 1-foot apart were made along lines perpendicular to the roadway or shoulder;
- A large number of photographs were taken, covering the area in detail.
